NASA CR-72855
R-8406

PROTECTIVE COATING SYSTEM FOR A REGENERATIVELY
COOLED THRUST CHAMBER

FINAL REPORT

Contract NAS3-11187

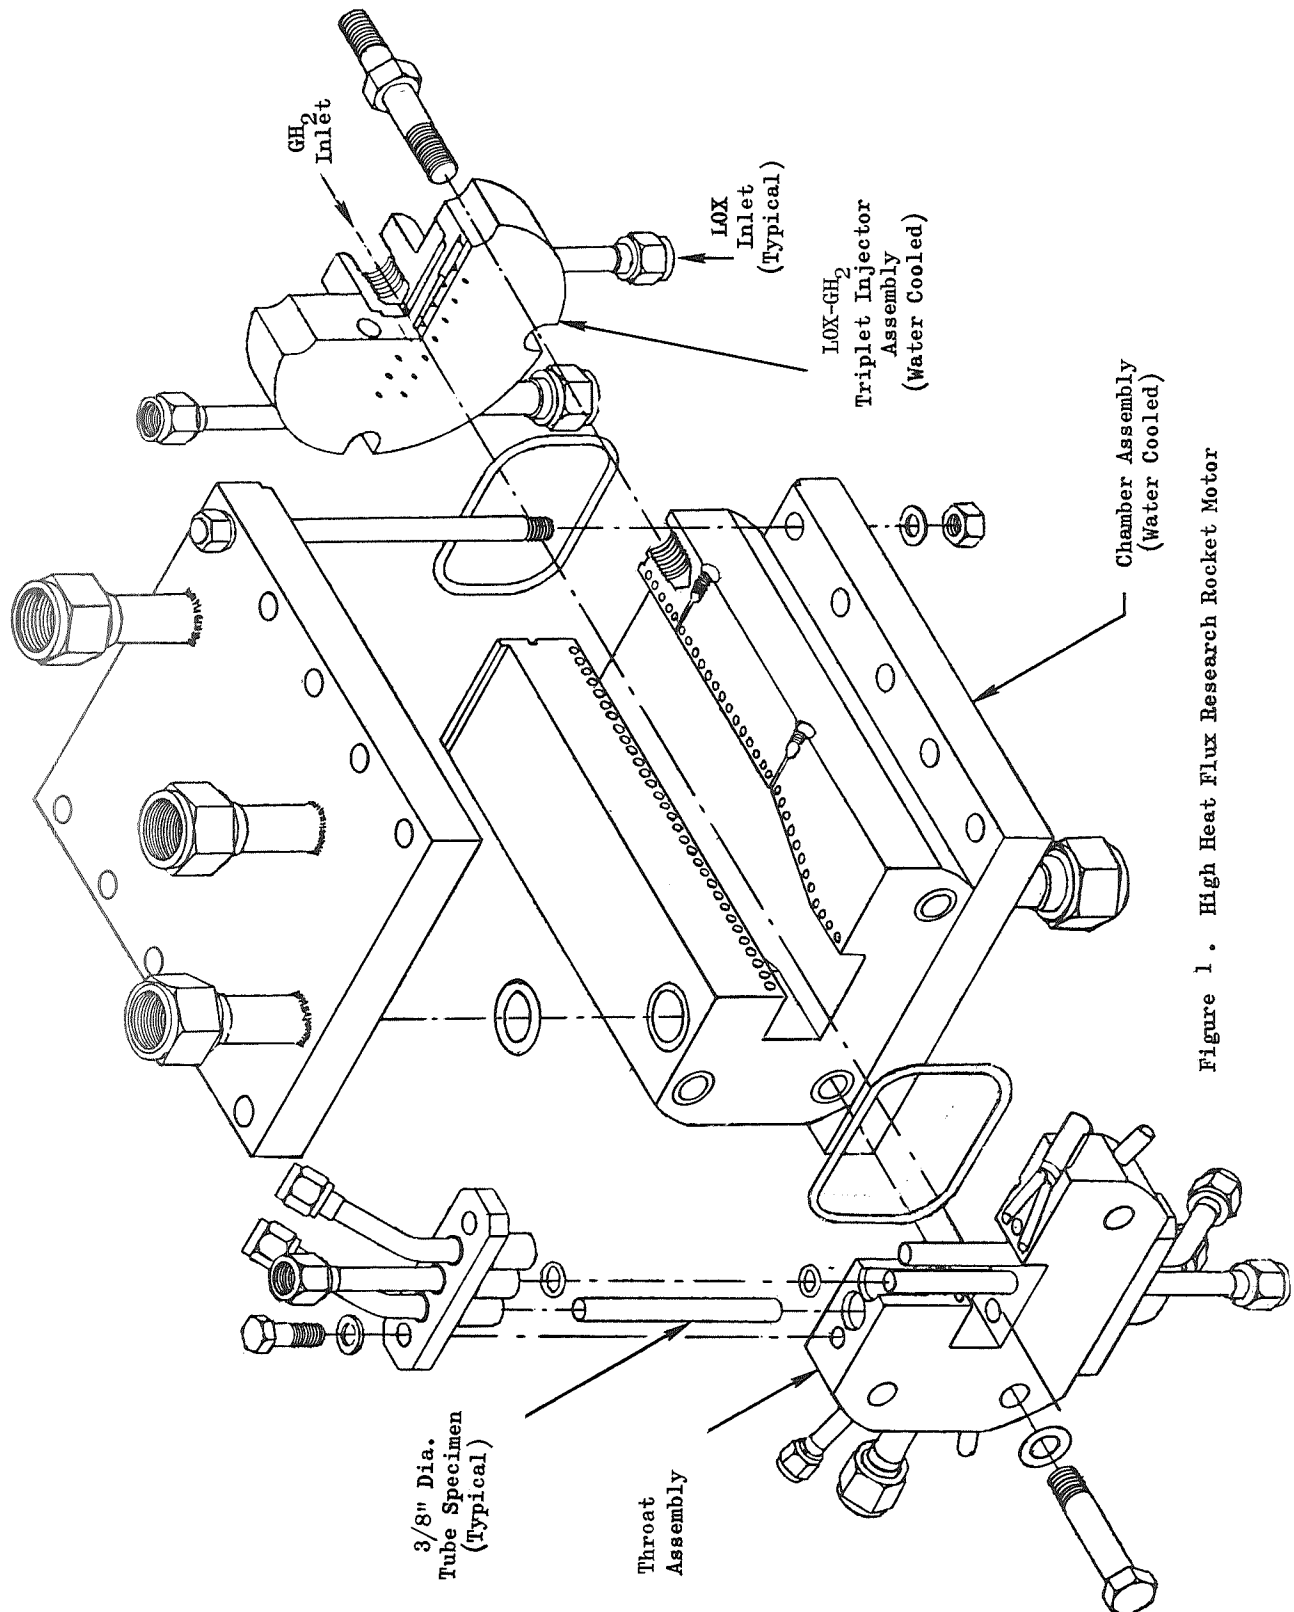
Figure 1. High Heat Flux Research Rocket Motor

A unique rocket motor that was previously designed and built at Rocketdyne on IR&D funds to test coated refractory tubes at high heat flux and shear conditions was employed. The complete rocket motor assembly is shown schematically in Figure 1. The water-cooled motor incorporates a removable throat section containing three 3/8-inch diameter tubes with a wall thickness of 0.015 inch (Figure 2). Exposed length of the tubes is one inch. The entire throat section can be removed after each test and replaced with another throat section containing different tubular specimens. The tubes, which were internally cooled with water, are normally easily removed, facilitating an alternate rapid replacement method. This procedure allows several tests to be run on different tube specimens in a single day of testing with the same engine so that complicated, intermittent scheduling of the test stand facilities is not necessary. External (hot-side) wall temperature and heat flux through the wall can be controlled by variation of a number of parameters, including chamber pressure, coating thickness, coolant pressure, and flowrate. In this way, the same coating system can be tested under different heat flux conditions during the same test run. This degree of control also permitted individual monitoring of coolant conditions through each tubular specimen.

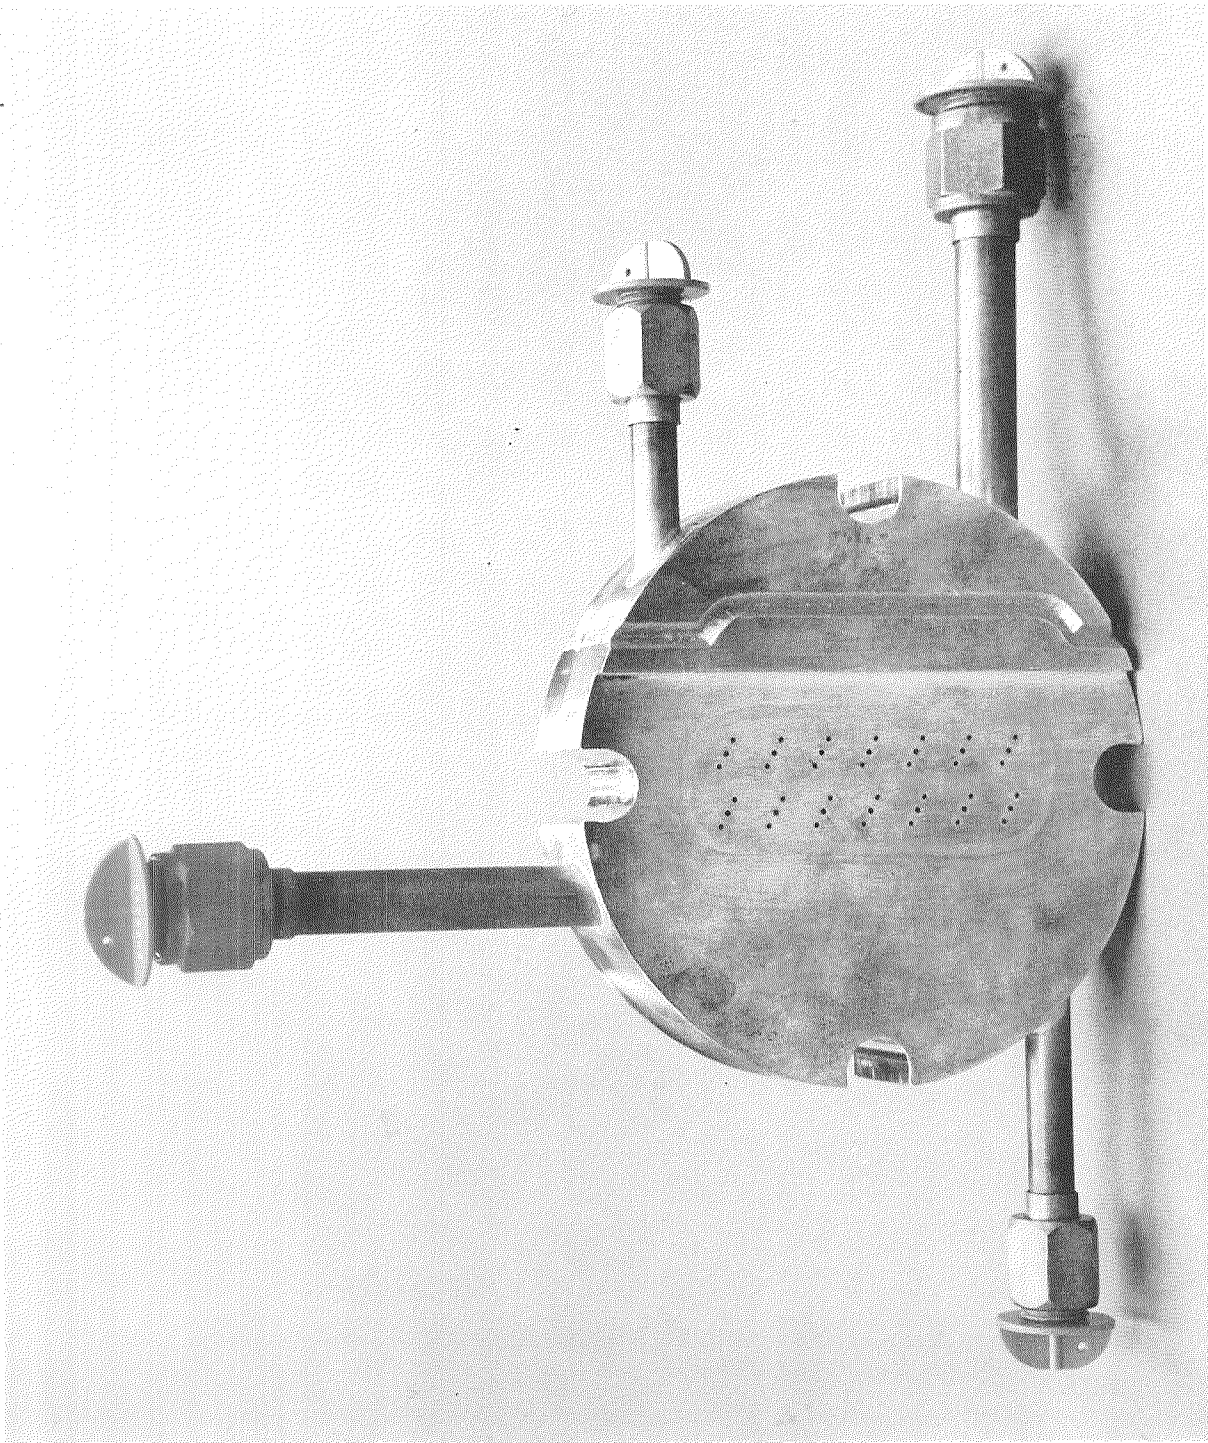
Figure 3. 14-Element Triplet Injector for the Small Test Rocket Engine

A 14-element gas-on-liquid triplet injector was utilized. Although the injector (Figure 3) was originally designed and tested with LF_2/GH_2 , modification to the LOX/GH_2 propellant combination was easily accomplished by enlarging the fuel side orifices. Ignition was accomplished by injecting a small quantity of gaseous fluorine during the fuel lead just prior to oxidizer valve actuation.

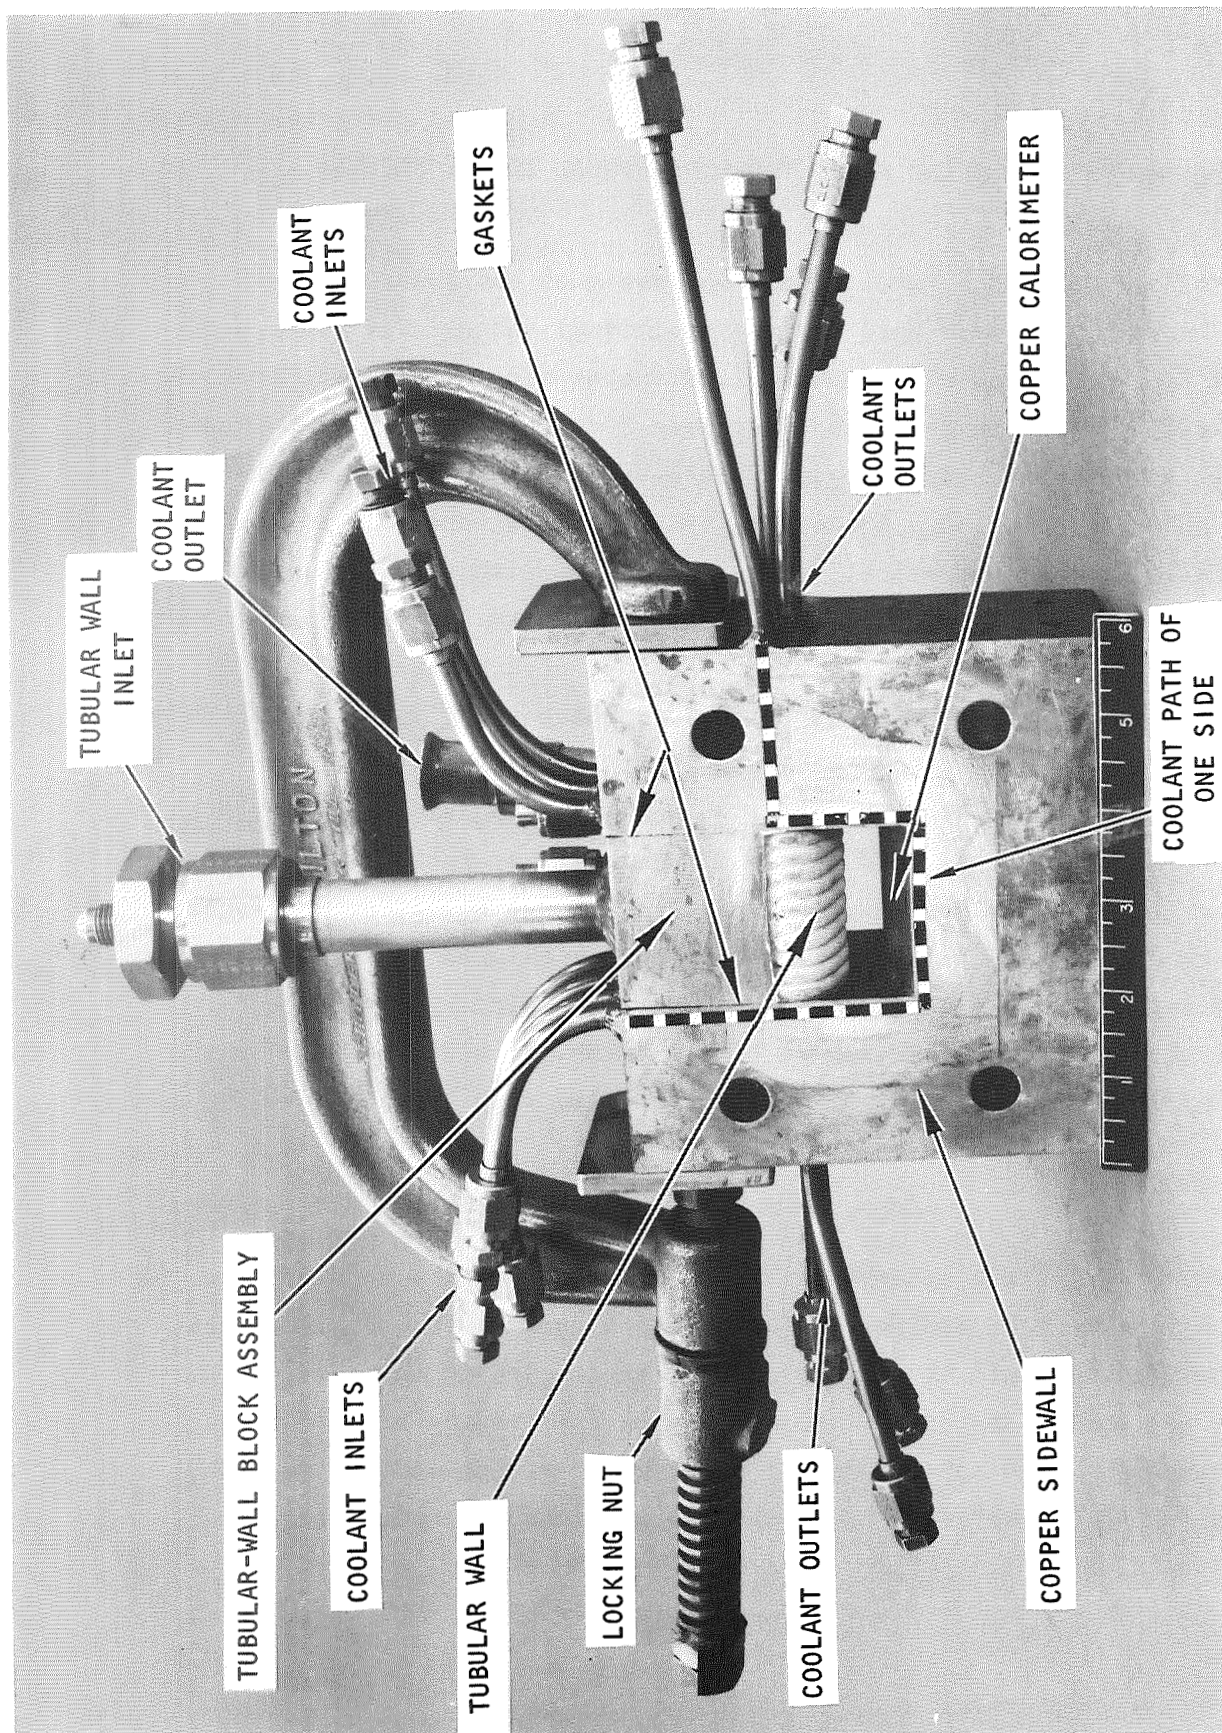
Figure 4. Two-Dimensional Throat Segment: Upstream Side

A throat segment with a tubular wall was designed and built for test firing in the same motor used for the individual tubes. The cross section of the throat was rectangular, 1.90 inches wide by 0.4 inch from the copper wall to the crowns of the Hastelloy-X tubes (Figure 4). By design, it had approximately the same cross-sectional area as the throat formed by the single tubes tested in Task-III. The tube-wall side was made of ten Hastelloy-X tubes, 0.190 inches O.D. with an 0.015-inch wall thickness, that were contoured individually and then brazed in the copper tubular-wall block assembly (Figures 4 and 5). Four braze cycles were required. The first was at 1910 F for 10 minutes using Nicoro braze (62 Cu-35 Au-3 Ni); the second, third, and fourth were at 1820 F for 10 minutes using a 50 Cu-50 Au braze alloy. All brazing was in a hydrogen atmosphere, and the braze did not seem to migrate over the tube crowns. Both ends of the tubular array protruded into large holes, or manifolds, that were drilled crosswise in the copper block (Figure 6). The ends of the manifolds on the side of the assembly were sealed by brazed copper plugs (Figure 7). The gaps formed by the interstices of the tubes where they went into the copper block also were filled with braze alloy (Figure 5).

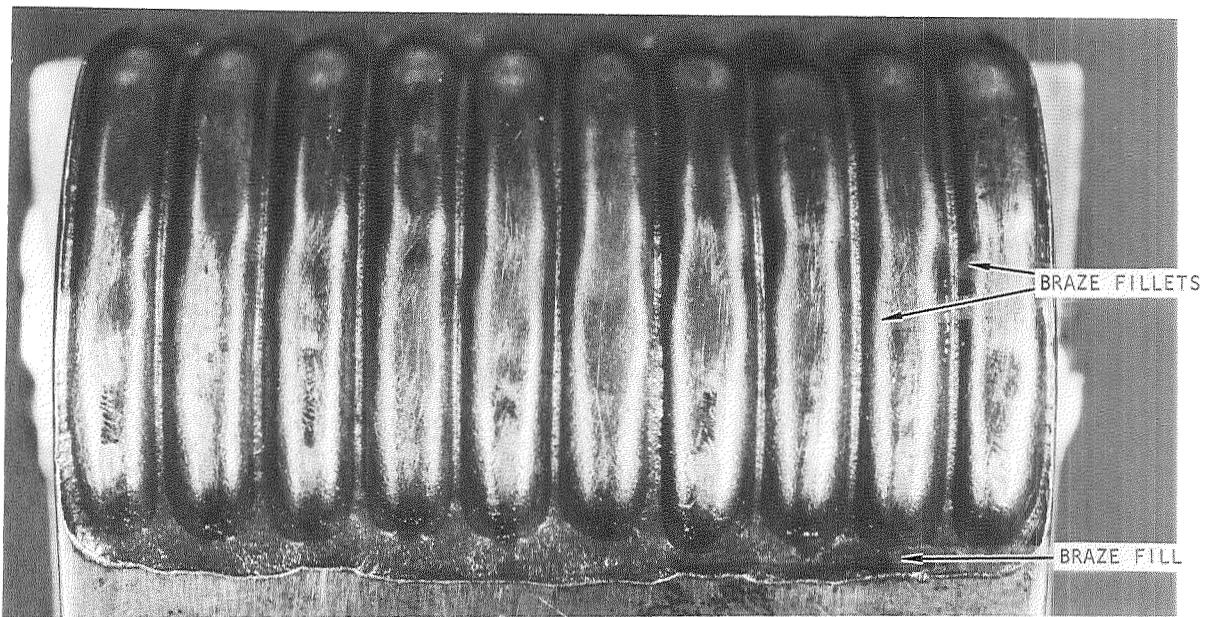
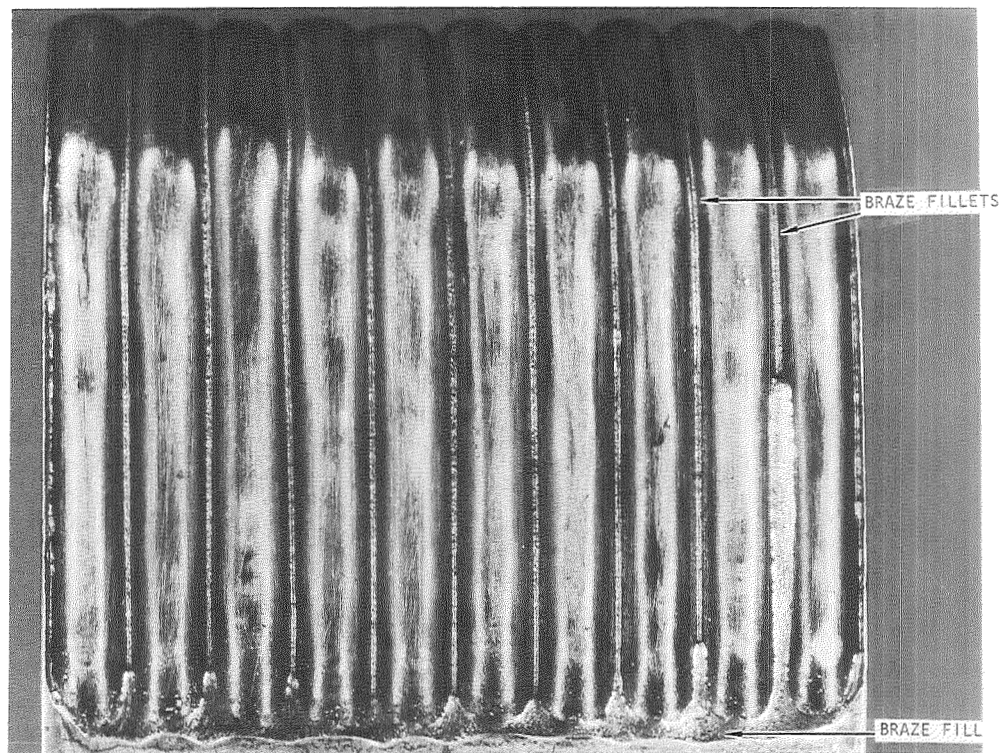
Figure 5. Views of the Uncoated Tubular Wall Showing the Brazed Fillets

(a) Upstream End: Front View

(b) Downstream End: Top View

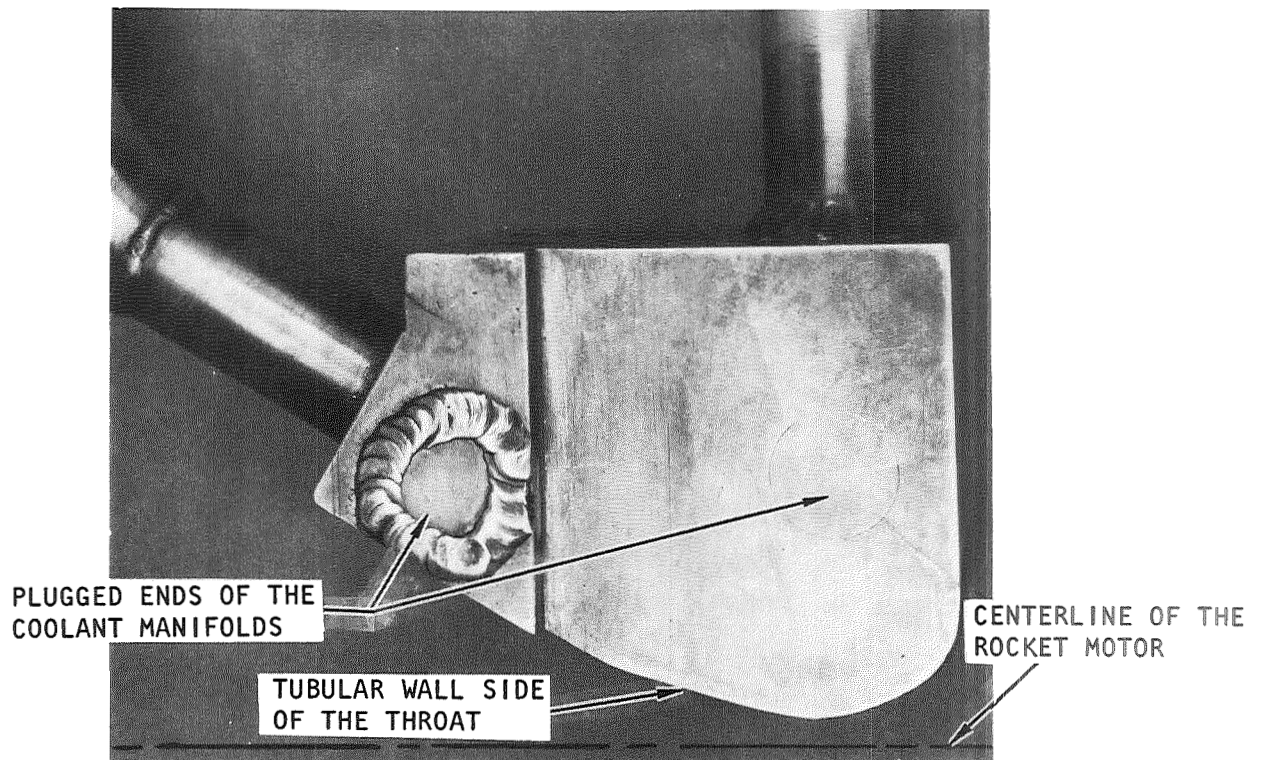
Figure 7. Side View of the Tubular-Wall Block Assembly

The tubular-wall block assembly was not brazed to the copper sidewalls because adherence of the coating to the substrate is damaged by a high-temperature anneal under isothermal conditions (Reference 1). Frictional forces, thus, were used to hold the throat insert in place during test firing. Rubberized asbestos gaskets, 12 1/2 mils thick were used to seal the sides of the tubular-wall block assembly to the copper sidewalls and the required frictional force was provided by an ordinary C-clamp (Figure 4). The design torque was applied to the C-clamp and a special locking nut was used to keep the C-clamp from loosening during testing. This torque, which was checked after each firing, did not change, and the tubular-wall block assembly did not move even a fraction of an inch during the three consecutive firings.

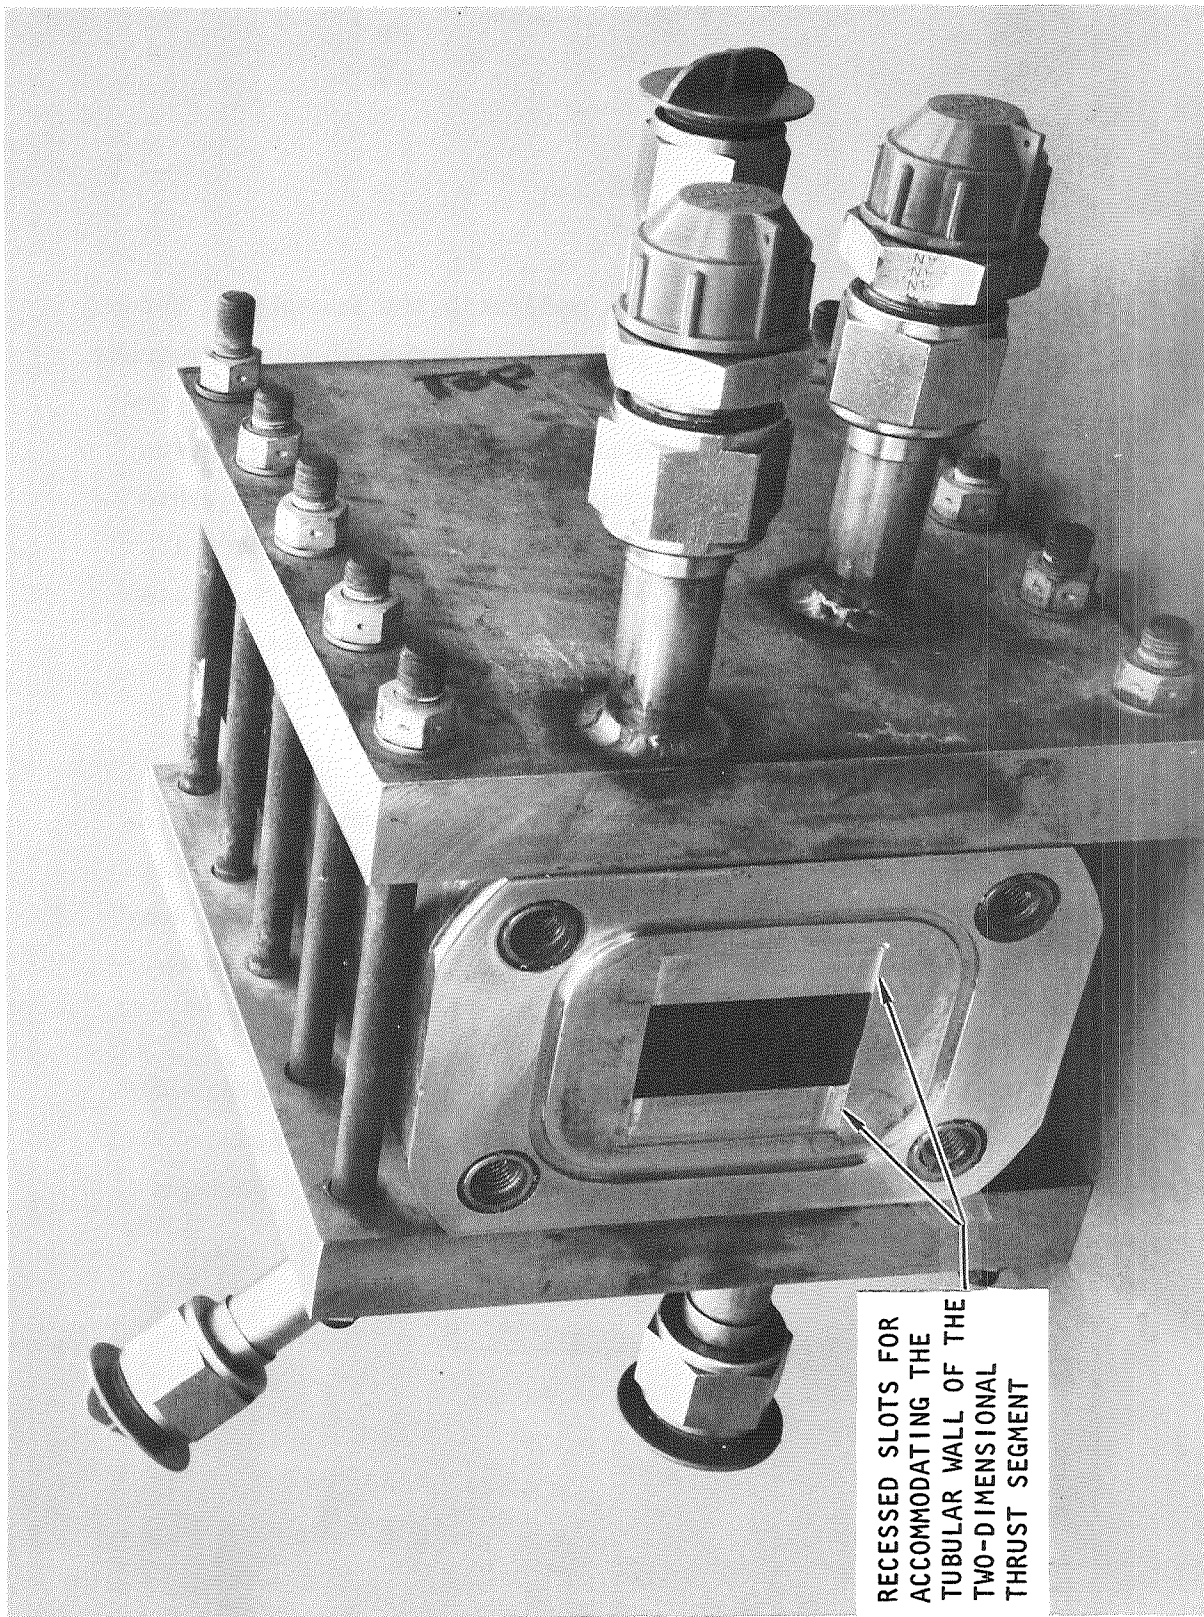
Figure 8. Combustor of the Two-Dimensional Motor Showing the Face That Mated With the Throat Segment

the face of the combustor. A recessed area had been milled in this face so that the protruding coated tubes would not be smashed when the throat insert was bolted to the combustor (refer to Fig. 8). Thus, there was an opening of unknown dimensions between the combustor face and the tubular wall. Hot combustion gases flowed into this open slot, but since the environmental conditions are unknown, the heat transfer conditions cannot be evaluated. Damage to the coating in this zone could have resulted from the milled slot being too small such that when the tube crowns expanded due to heating from the combustion gases, they pushed into the face of the combustor, crushing the coating.

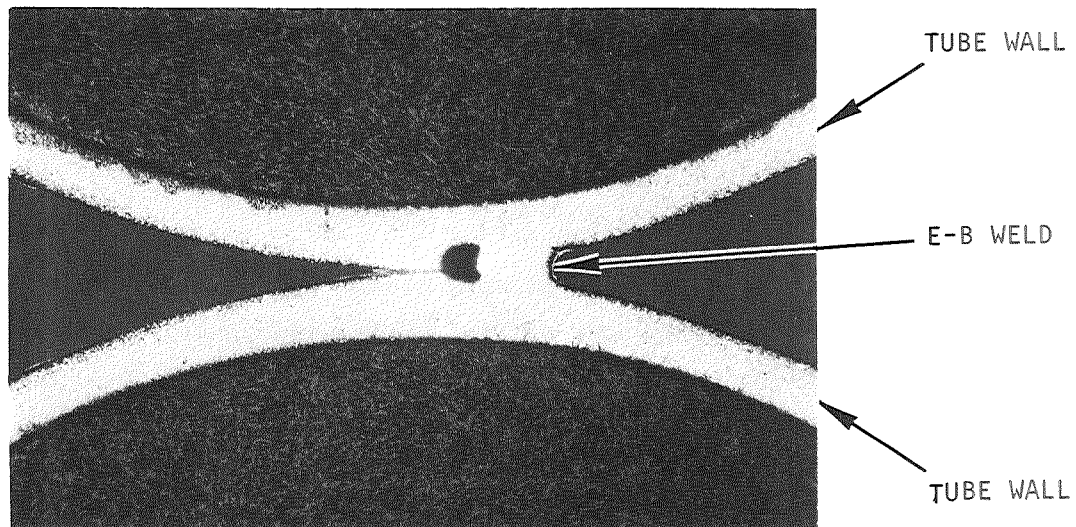
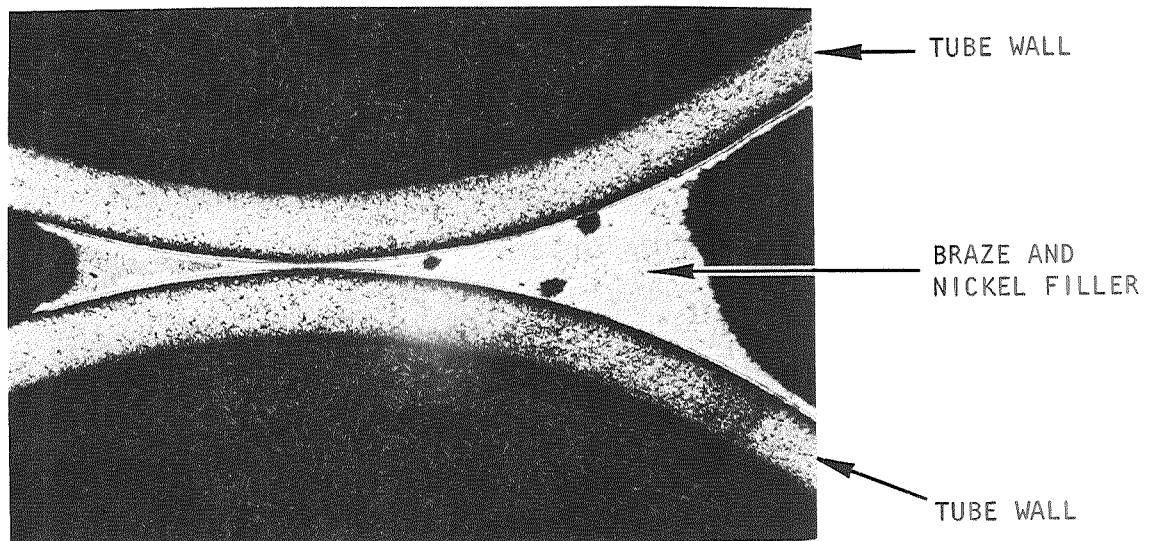
Figure 9. Joined Zones of Tube Pair Type of Specimen

Figure a. Electron-Beam Weld Between Two Hastelloy-X Tubes
(0.015 Inch Wall Thickness; Mag X25)

Figure b. Brazed Zone Between Two Hastelloy-X Tubes
(0.015 Inch Wall Thickness; Mag X25; 10%
Oxalic Acid-Electrolytic Etch)

Both single- and double-tube geometries were tested. The substrates were 3/8-inch diameter Hastelloy-X tubes with 0.015 inch wall. The double-tube specimens were made by joining two of these tubes by electron-beam weld or braze (Fig. 9). The braze alloy was AMS 4777:

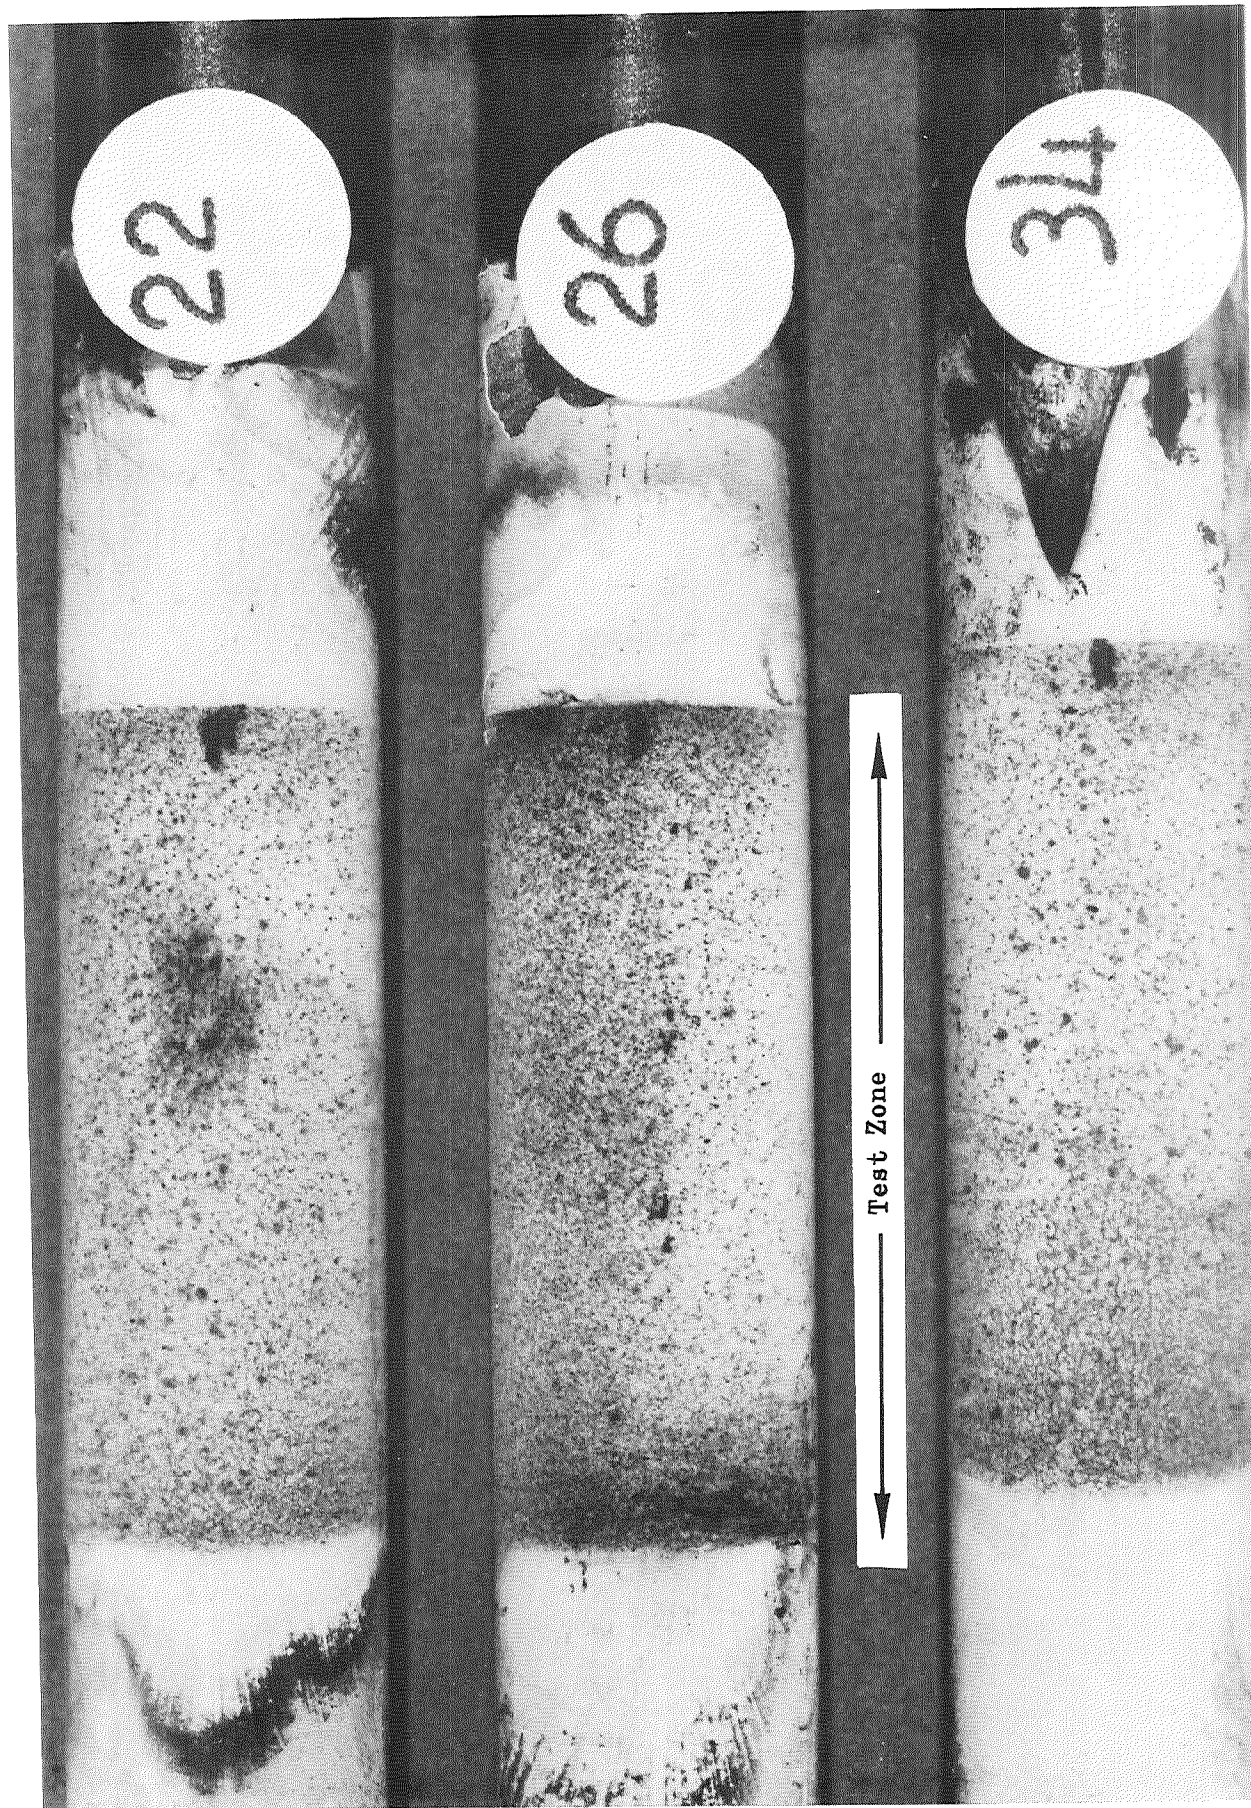
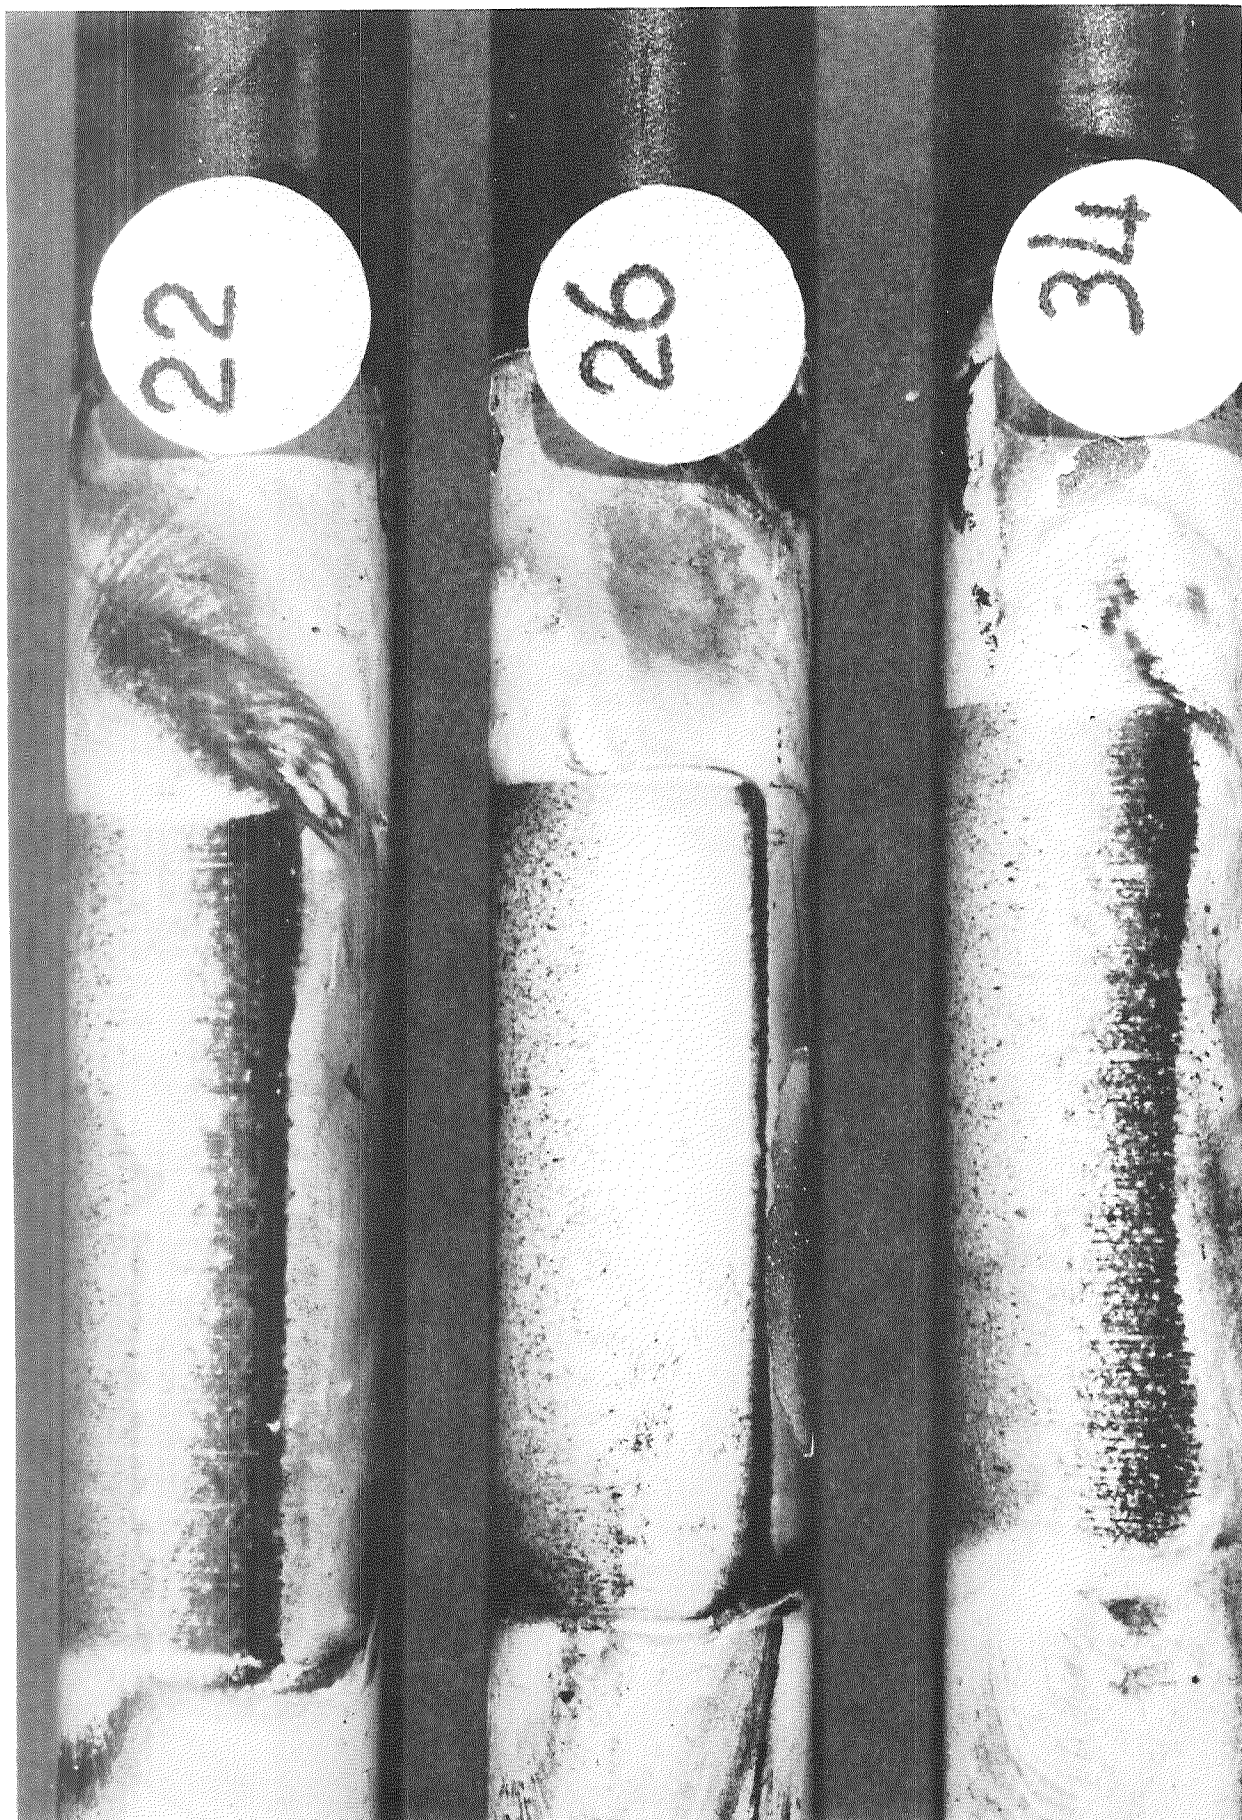
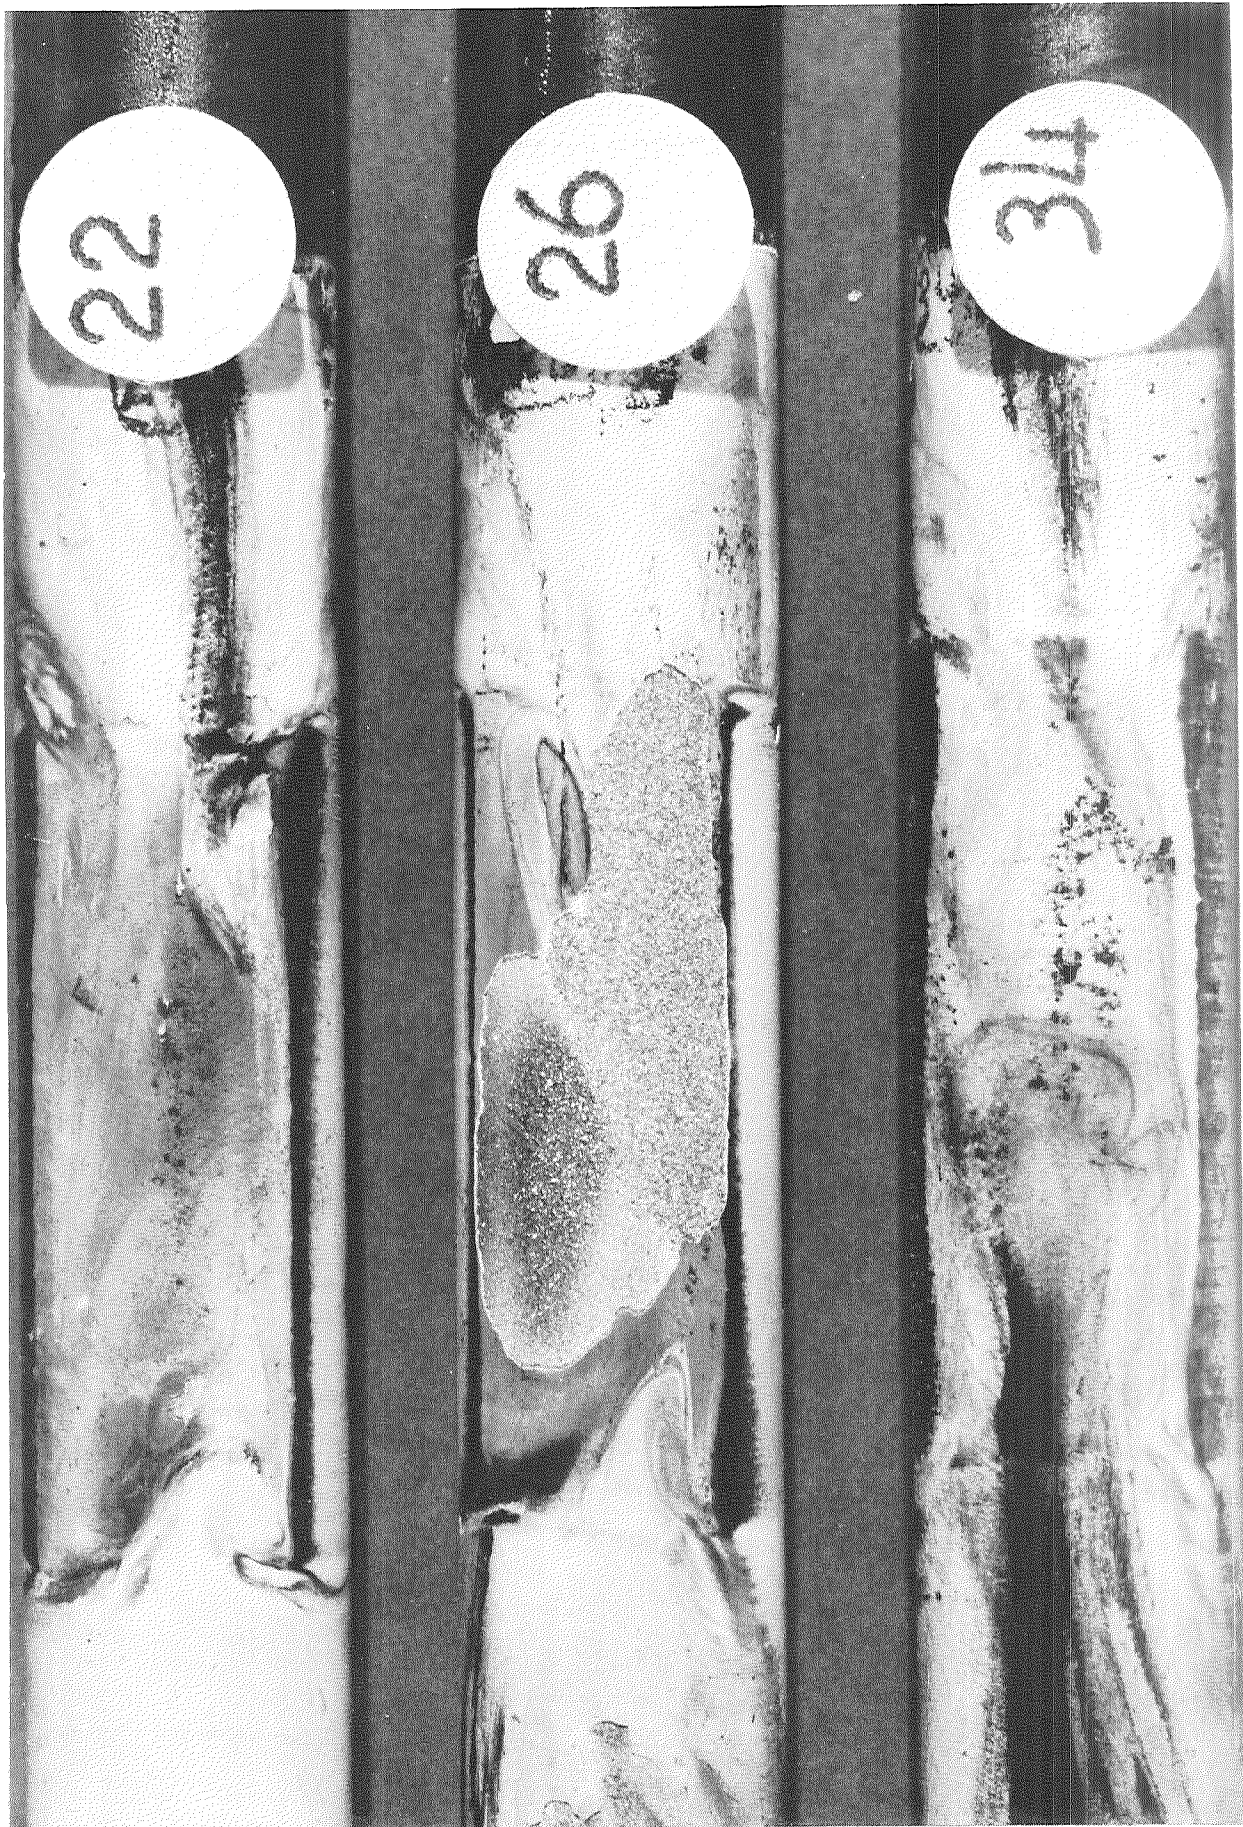
Figure 12. Coated-Tube Specimens After Rocket Engine Test at $P_c = 302$ psia. Magnification X4-1/2.

(a) Front: The Surfaces Facing the Injector.

(b) Side: $P_c = 302$ psi

(c) Rear: The Surfaces Away From The Injector. $P_c = 302 \text{ psi}$

Macroscopic Examination. Figures 12 through 15 show each test specimen in the posttest condition in front, side and rear views. Significantly, no spalling occurred, nor was erosion or any detrimental chemical reaction apparent in the test zone of the front face of any specimen (Figs. 12a, 13a, 14a, and 15a). The spalling seen in specimens 25, 28, and 32 (Fig. 14) occurred during removal from the throat fixture. Specimens 25 and 28 had to be sawed out while specimen 32 was physically forced through the entry hole. The difficulty in removal was caused by bowing of the tubes during testing. Bowing of the tube to this extent undoubtedly subjected the coating to untypically high stresses, particularly on the downstream side where the coating was placed in tension.

The coating on the front face appeared darkened after testing, mainly due to the formation of small black marks. The marks seemed to be of two kinds: (1) surface stains which formed smears and wavy lines (see Fig. 12a, specimen 34), and (2) spots which appeared to penetrate into the coating.

Inspection of the sides of the specimens (Figs. 12b, 13b, 14b, and 15b) also show that there was no spalling, erosion, or detrimental chemical reaction. Two significant features are readily apparent in these views. First, the point of gas flow separation is shown by the sharp edges of colored areas and by the abrupt end of the flow lines of fused coating. Color of these darkened areas was black and burnt sienna. The black smears originating at the ends of some test specimens are due to burned gaskets. Second, when spalling occurred on the downstream side of the specimen, it stopped where the gases separated from the coating surface. This is most apparent in specimen 26 (Fig. 12b and c) where downstream spalling was greatest.
